**SCREENING SITE INSPECTION REPORT
FOR
GREEN VALLEY LANDFILL
NAPERVILLE, ILLINOIS
U.S. EPA ID: ILD060360898
SS ID: NONE
TDD: F05-8802-035
PAN: FIL0254SA**

OCTOBER 10, 1989

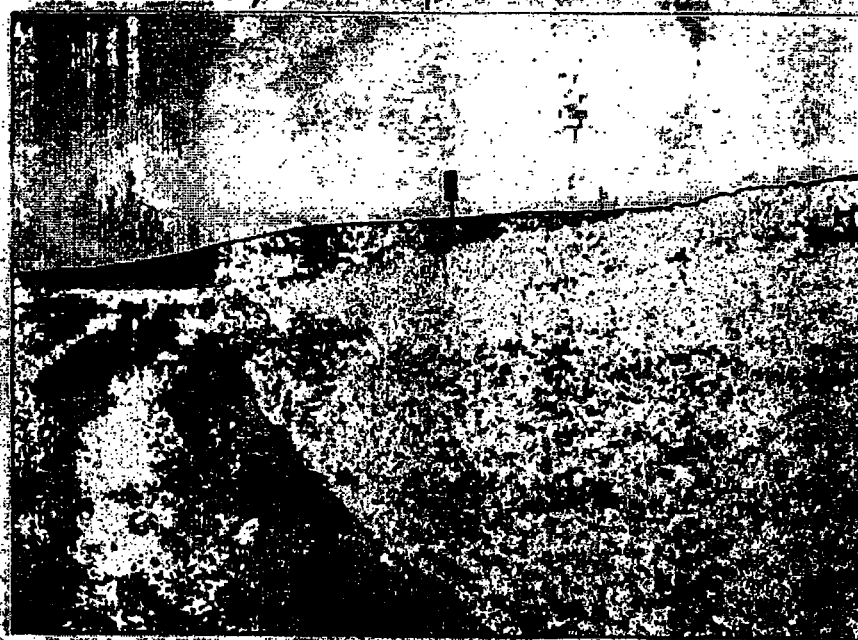
DESCRIPTION: > Photo (facing east) showing north slope of previously
> filled area, methane gas vent flare, vegetation, and drainage
south of northern perimeter road.

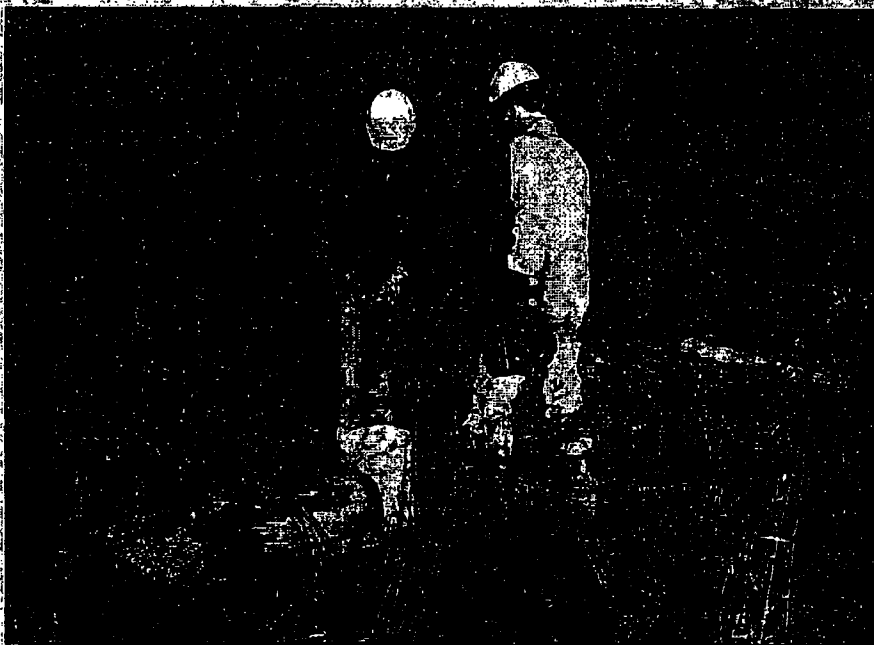
> MW1

DESCRIPTION: > monitoring well 1 being opened prior to purging

> and subsequent sample collection.

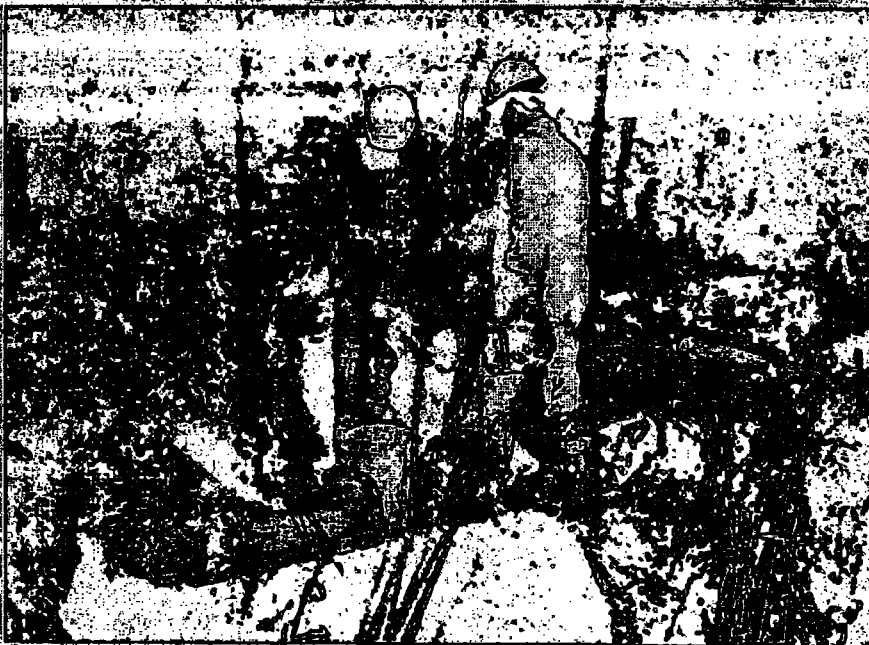
> MW 1

DESCRIPTION: > Monitoring well 1 being opened prior to purging
> and subsequent sample collection.
